A Review Study on Performance of Stone Masonry Building Under EarthquakePulkit Gupta¹, Dr. Suresh Singh Sankhla^{2*}¹*P.hd. Scholar, Department of Architecture and Town Planning, M.B.M. Engineering College,
J.N.V. University, Jodhpur, Rajasthan, India*^{2*}*Associate Professor, Department of Structural Engineering, M.B.M. Engineering College,
J.N.V. University, Jodhpur, Rajasthan, India*

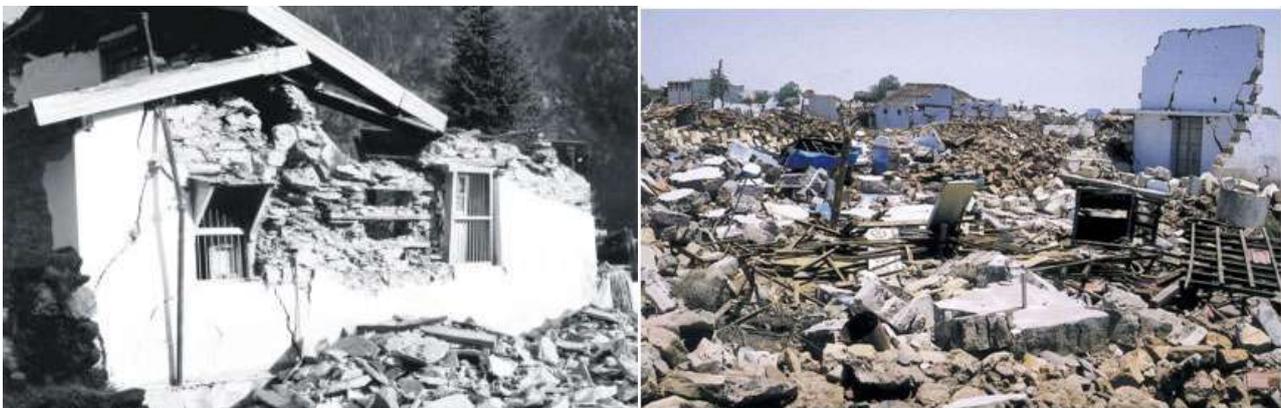
Figure 1: Damage to stone masonry houses and Collapse of the housing colony at Gawana

The earthquake caused enormous destruction of houses and loss of life, killing nearly 770 people and injured nearly 5000, mostly all due to collapse of random rubble residential houses. The affected region lies between seismic zone IV and V according to seismic zoning map of India. The maximum affected area was Uttarkashi, Tehri and Chamoli districts. Telecommunication and power supply were badly effected due to damaged telephone and electric poles. Rubble stone masonry houses in mud mortar close to the severely effected area were totally collapsed and others got severe damage. Many school and health buildings were also damaged.

Many houses were severely damaged/collapsed. Gawana steel lattice bridge located about 6 km from Uttarkashi on road to Gangotri collapsed, severely affecting the relief and rescue operations immediately after the earthquake. Widespread rock falls landslides/rock slides were observed mostly along the road causing heavy damage to hilly roads and blocking it.

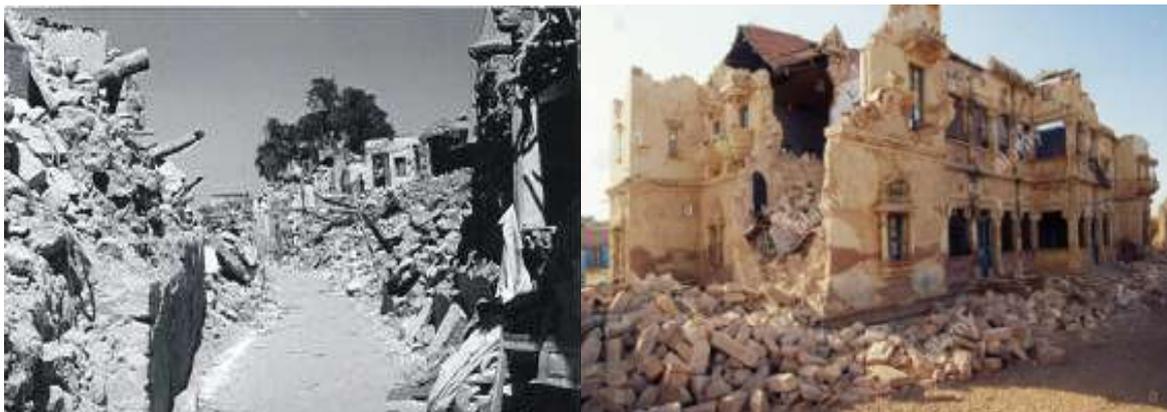
Figure 2: Damage to stone masonry houses and Collapse of two storey stone masonry building Bachau

Most of the rural construction of mud, adobe, burnt brick and stone masonry either in mud or cement mortar have shown severe damage or collapsed. The stone masonry buildings undergo severe damage resulting in complete collapse and pileup in a heap of stones (Fig. 2). The inertia forces due to roof/floor is transmitted to the top of the walls and where the roofing material is improperly tied to the wall, it will be dislodged. The weak roof support connection is the cause of separation of roof from the support and lead to complete collapse. At many places the height of the random rubble stone masonry walls in mud mortar/ poor cement mortar was about 5.0m.
